Property Inspection Report

1487 47th ST NW, Washington, DC 20001 Inspection prepared for: Rowhouse Buyer Date of Inspection: 8/16/2017 Time: 3:00PM - 5:30PM

Inspector: Ed Snope Virginia Certified Home Inspector #3380 000529, expires 4/30/2017 1614 N Wakefield St, Arlington, VA 22207 Phone: 703-304-3925 Fax: 703-525-8440

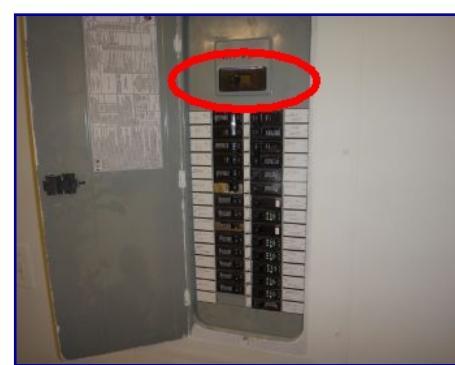
FYI: Main disconnect in panel. Panel located in basement hall.

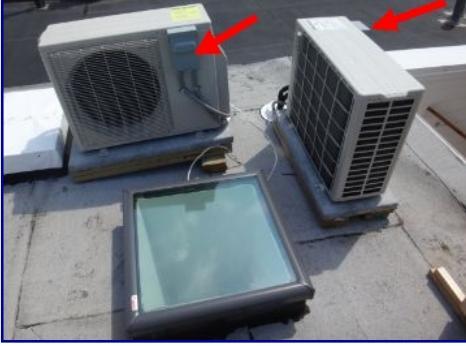
FYI: Heat pump service disconnect. Roof.

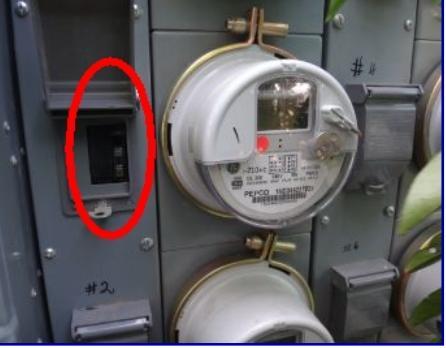
FYI: Main disconnect located at meter, NW corner.

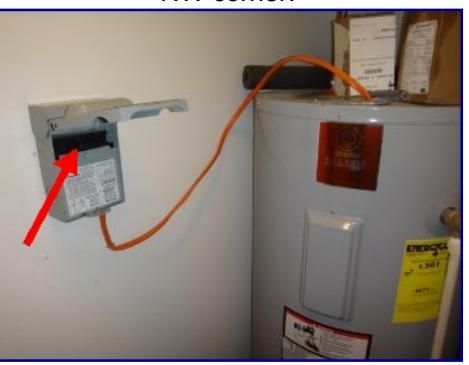
FYI: Water heater service disconnect. Water heater closet.

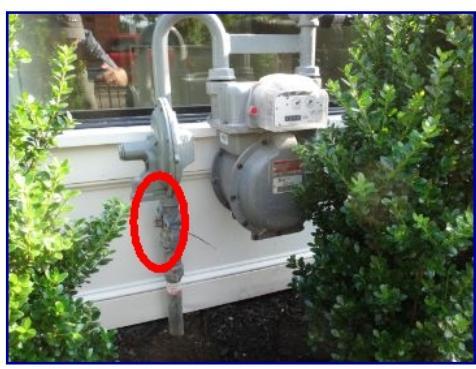
FYI: Main gas shutoff valve at meter. Meter located at unit #5.

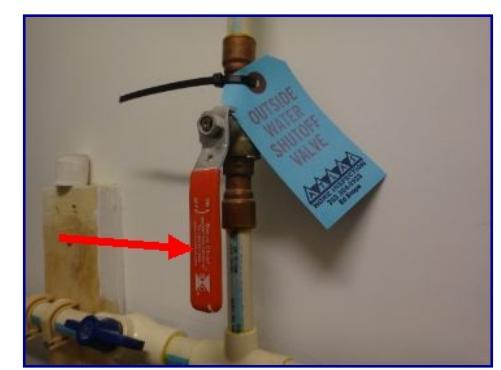
FYI: Exterior hose bib shutoff valve.

Water heater closet.

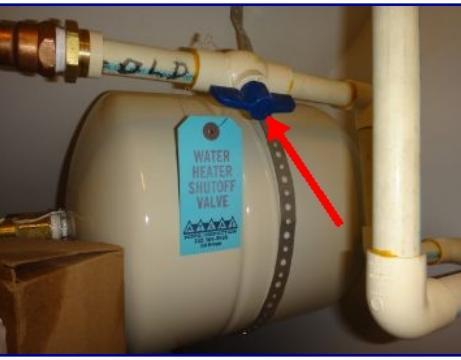
FYI: Water heater water shutoff valve. Water heater closet.

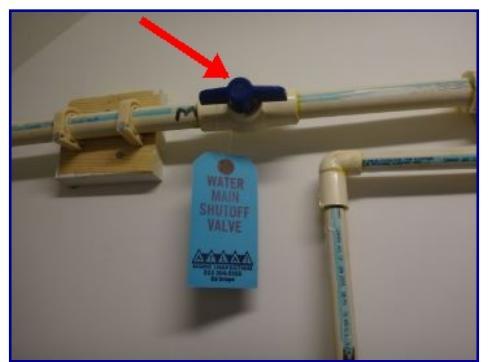
FYI: Main water shutoff valve. Water heater closet.

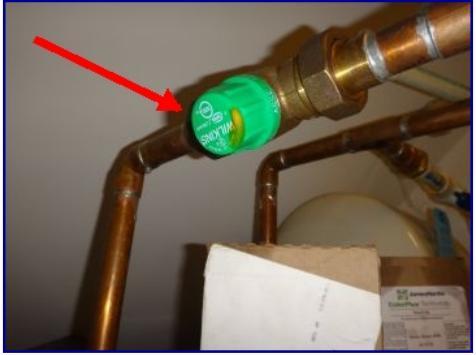
FYI: Tempering valve installed. Water heater closet.

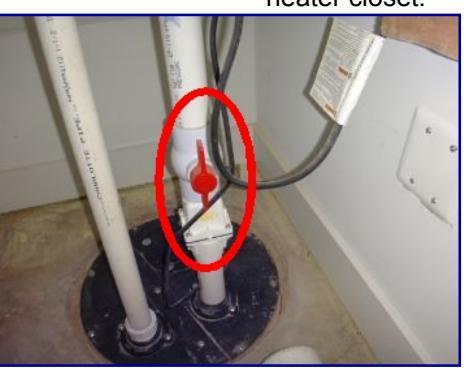
FYI: Sanitary pump drain water shutoff valve.

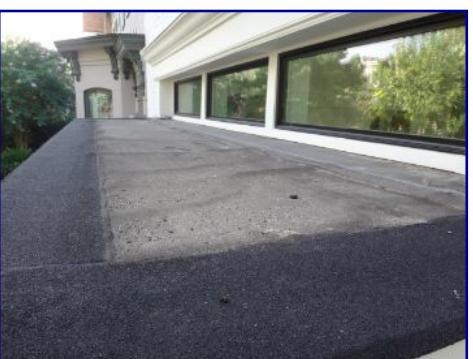
• Numerous concerns with roofing including loose roofing, reversed lapping, sealant failed and missing, drain slope or roof drain missing, low clearance between roofing and window frames, and flashing not visible.

Reversed lapping. Roofing loose. Sealant failed at seams. Sealant missing at trim. Drain slope or roof drain missing. Low window clearance.

• Sealant failed or missing. Repair. FYI: Prevent leaks and water damage. Recommend sealing all fasteners with roofing sealant such as Loctite PL S30 or Liquid Nails RR-808.

Reversed lapping. Repair. FYI: Slope the roof to an outer corner or install a roof drain.
Roofing loose. Repair or replace. FYI: Prevent leaks and water damage. Recommend replacement.

• Drain slope missing. Repair. FYI: Prevent leaks and water damage. Install a roof drain or reslope the roofing.

• Clearance low. Flashing not visible. Repair or maintain. FYI: Recommend 2 inches of visible flashing below horizontal trim above roofing. Ensure that roofing drains away from walls. Maintain and monitor.

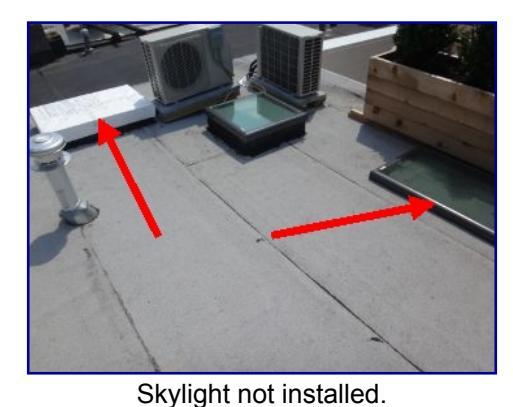
• Skylight not installed. Repair. FYI: Ensure that the skylight is installed.

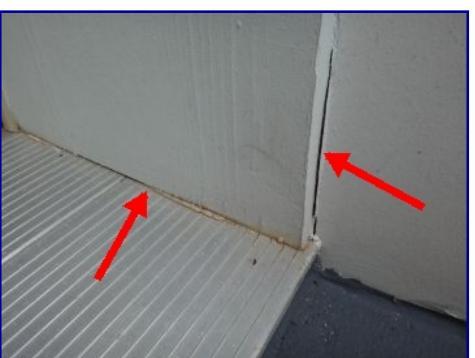
Caulk failed and missing. Front door frame at threshold.

• Caulk failed or missing. Repair. FYI: Prevent water damage. Remove all loose or split caulk, clean the surface, and prime any bare wood before caulking with a paintable caulk. Use a backer

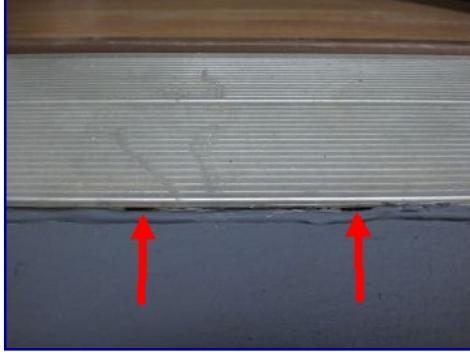
Caulk missing. Front door threshold.

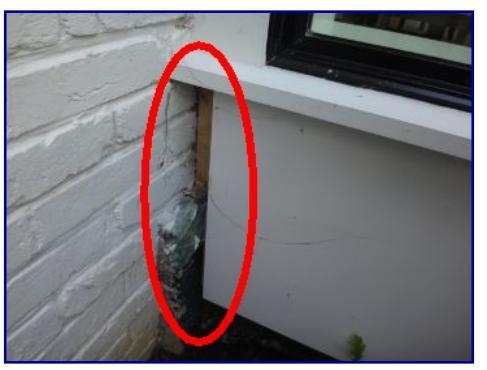
Trim missing.

rod for large voids. Not all areas were visible during the inspection and the entire siding and trim need to be inspected. Caulking and painting are regular maintenance which will prolong the life of materials. Silicone not recommended.Trim missing. Repair. FYI: Install trim and seal or caulk all voids.

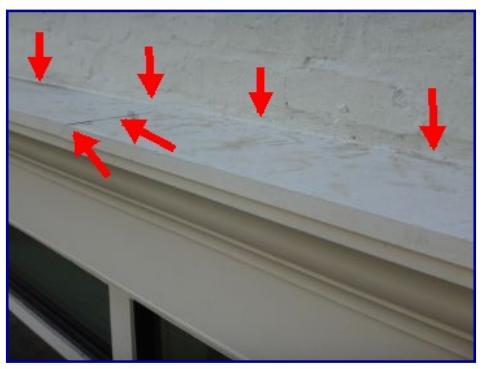
Caulk failed. Flashing or drain slope not visible. Exterior window frame tops.

• Drain slope missing. Repair. FYI: Prevent leaks and water damage. Install sloped horizontal trim or flashing. Expect maintenance.

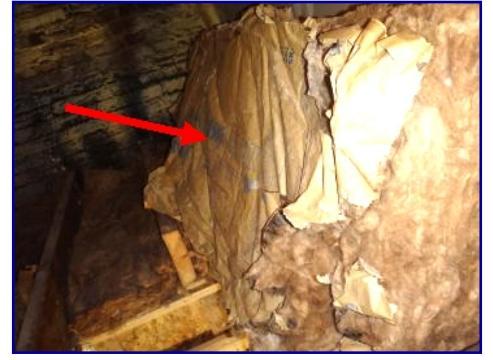
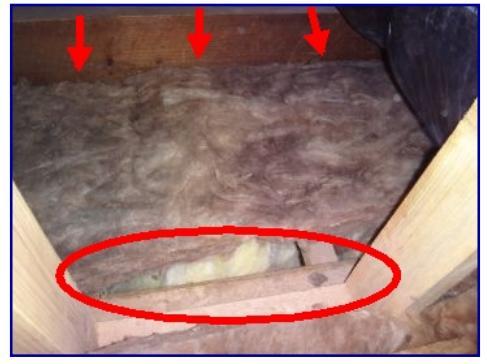
Insulation displaced. Loose fit. Numerous areas.

Exposed flammable backing.

SAFETY HAZARD- Exposed flammable backing. Repair. FYI: Fire hazard. Manufacturers instructions state that the insulation backing is flammable and not to be left exposed. Remove or cover with a nonflammable surface such as drywall or paneling.
 Insulation displaced. Repair. FYI: Prevent energy loss. Install insulation with no air

• Insulation displaced. Repair. Fill Prevent energy loss, install insulation with no air gaps between the insulation and the conditioned space and with no air gaps between the insulation batts and joists or other batts.

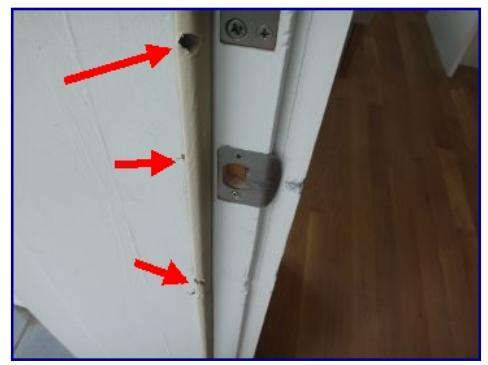
Weatherstripping damaged. Door frame. Front door.

• Weatherstripping damaged. Door frame. Replace.

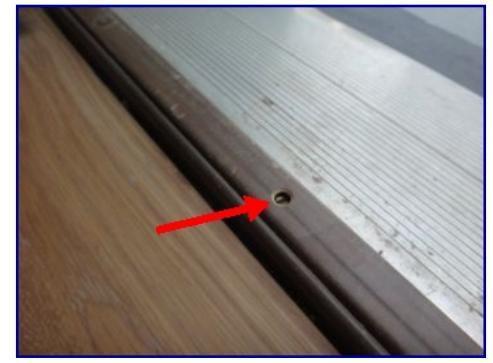
Threshold cap missing. Front door.

Threshold cap missing. Repair. FYI: Prevent damage. Replace the cap or replace the threshold.

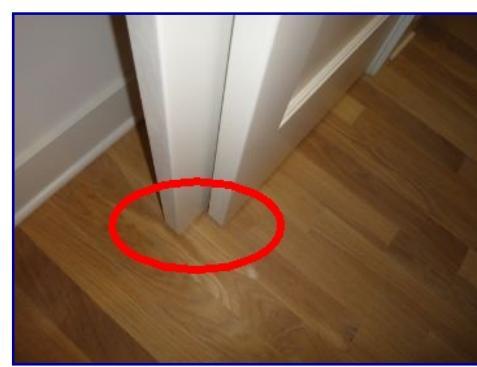
Sliding door guides missing. Basement hall closet.

• Sliding door guides missing. Repair. FYI: Prevent injury or damage. Install door bottom

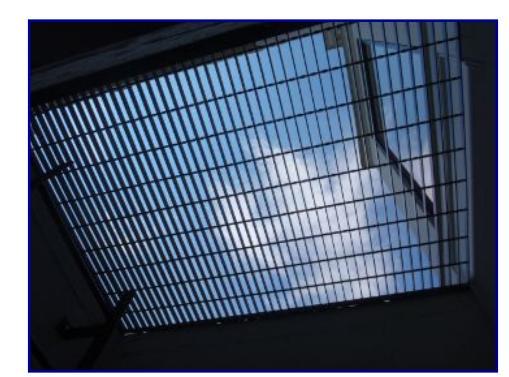
Window well cover loose. Cover heavy. Basement bedroom egress well.

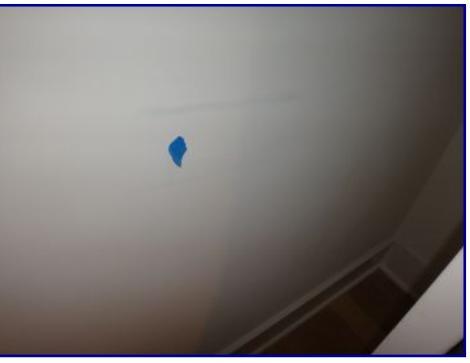
Wall dirty. Numerous areas.

Observations: • Wall dirty. Repair. FYI: Clean or prime and paint.

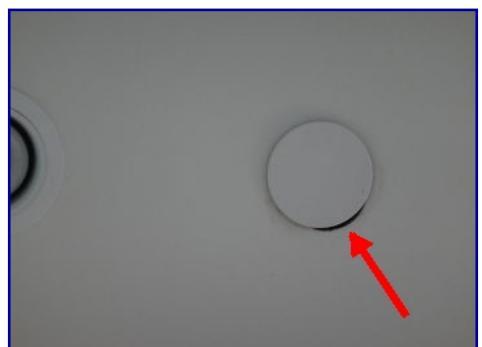
Sprinklers offset. Several areas.

Sprinkler damaged. Basement hall.

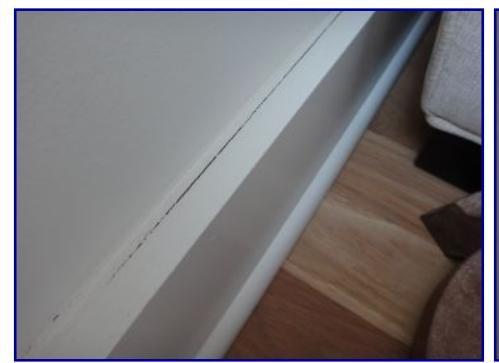
Trim loose. Caulk failed. Baseboard. Living room.

Trim loose. Repair. FYI: Prevent further damage. Fasteners missing, too short, or not nailed into studs. Secure the trim a minimum of every 16" to the framing. • Caulk failed. Repair. FYI: Secure loose trim, remove split caulk, and prime any bare wood

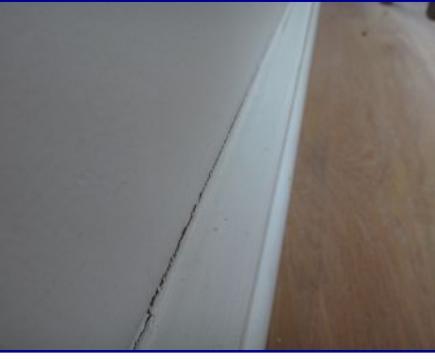
Trim loose. Caulk failed. Baseboard.

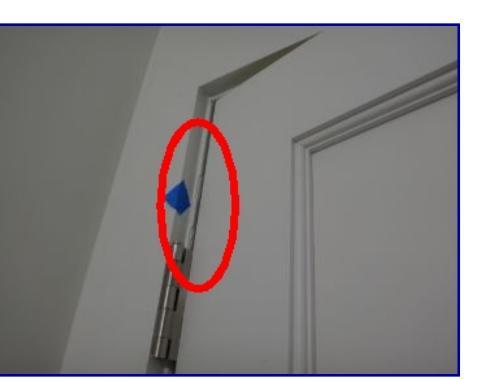
Trim damaged. Basement bathroom door frame.

- before caulking.
- Trim damaged. Repair or replace. FYI: Recommend replacing damaged.
 Trim dirty. Repair. FYI: Clean or prime and paint with a gloss paint. FYI: Recommend replacing damaged boards.

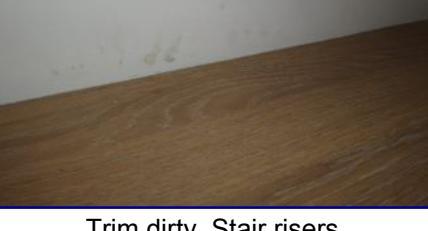
Trim dirty. Stair risers.

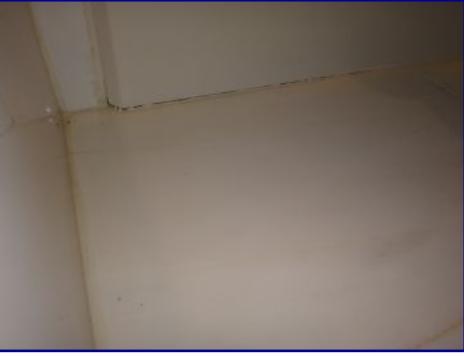
Caulk missing or failed. Floor perimeter. Basement bathroom.

• Caulk failed or missing. Repair. FYI: Prevent leaks and water damage. Caulk at all angled planes around sinks, toilets, bathtubs, showers, clothes washers, and exterior doors. Remove any split or damaged caulk or loose grout before caulking.

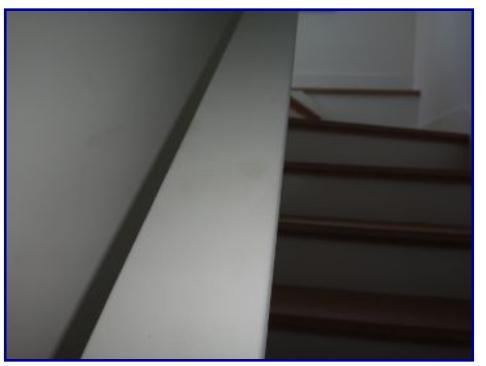
Railings dirty. Flat paint.

• SAFETY HAZARD- Railing dirty. Repair. FYI: Clean or prime and paint with a gloss paint.

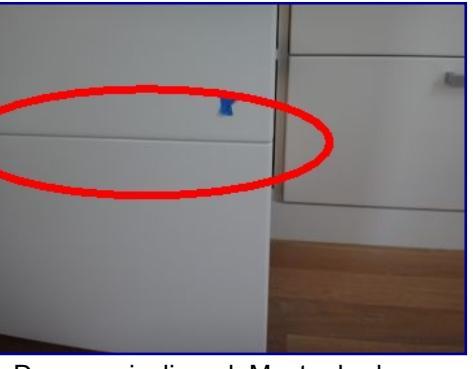
Drawer misaligned. Master bedroom.

Drawers misaligned. Repair. FYI: Adjust the drawer guides so that the drawers open maintaining a gap.
Cabinet dirty. Repair. FYI: Prevent damage. Clean cabinet and drawer hardware.

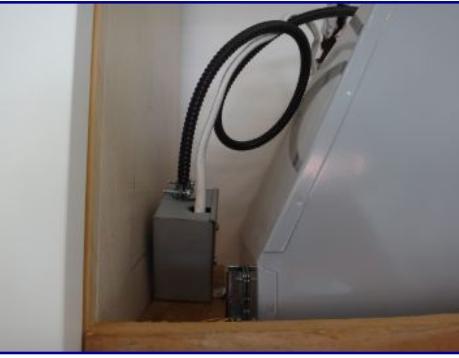
Junction box loose. Range hood.

• SAFETY HAZARD- Junction box loose. Repair. FYI: Prevent damage. Secure all junction boxes to structural members.

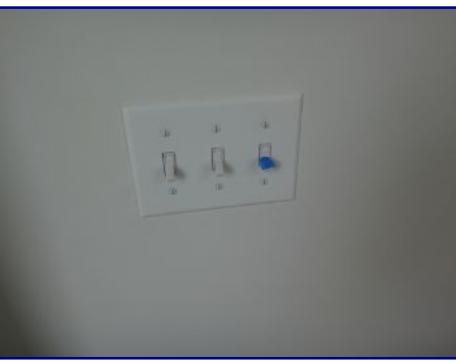
Switch inoperable. Master bedroom.

• Switch inoperable. Further evaluation advised. FYI: Confirm function of all switches.

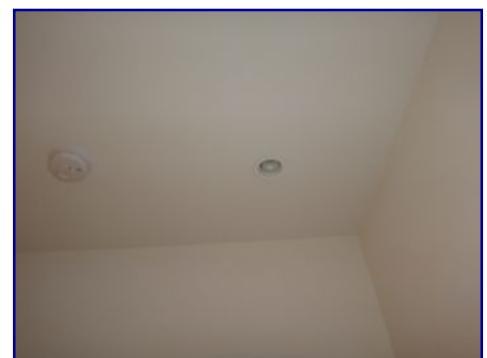
Light fixture inoperable. Basement bedroom.

Cover missing. Master bathroom shower.

• Light fixture inoperable. Replace bulb or repair. FYI: Replace or test bulbs to determine if bulb is burnt out or the fixture or wiring is faulty. • SAFETY HAZARD- Cover missing. Shower. Repair. FYI: Install covered, GFCI protected light

fixtures above showers.

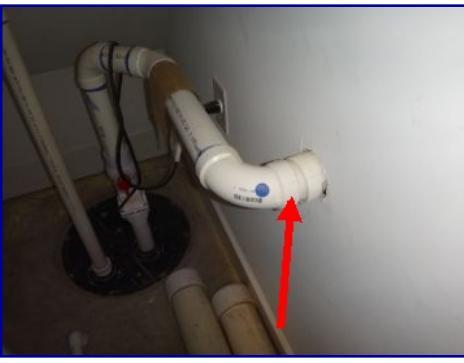
Pipe loose. Sanitary drain.

Observations: • Pipe loose. Sanitary drain pipe. Repair. FYI: Prevent leaks and water damage. Secure the pipe to the structure.

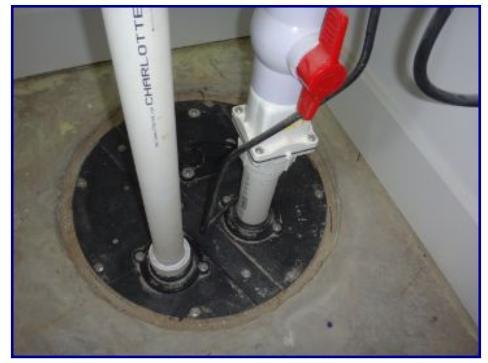
Seal missing. Well cover.

• SAFETY HAZARD- Seal not visible. Repair. FYI: Sewer gas evident at the time of the inspection. Seal the lid with an airtight seal.

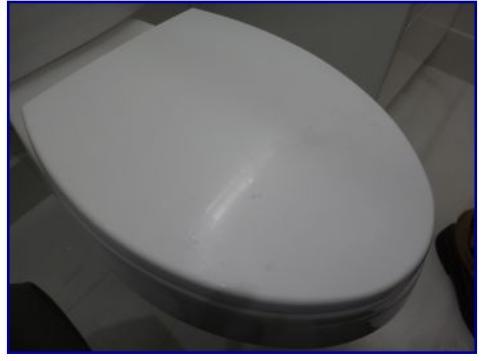
Toilet seat damaged. Basement bathroom.

Observations: • Toilet seat lid damaged. Replace. FYI: Scratched.

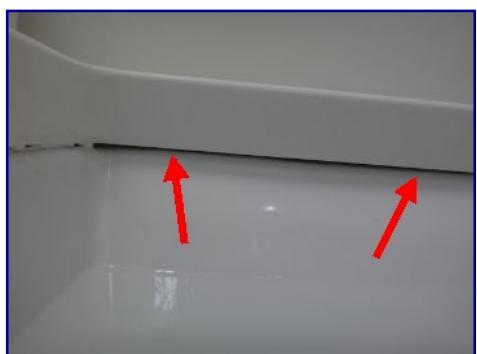
bathroom.

Caulk not visible. Sink under countertop. Basement

Caulk not visible under countertop. Repair. FYI: Prevent leaks or bacteria. Ensure that the seam around the sink is cleaned before sealing with a countertop caulk. Recommend levelling the void with caulk so that particles or fluids don't get trapped in the seam. Silicone not recommended.

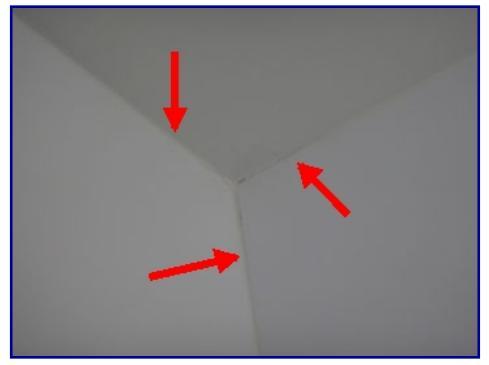
Caulk failed. Basement bathroom, at ceiling.

Caulk failed or missing. Repair. FYI: Prevent leaks or water damage. Caulk where the shower meets the wall and floor or trim, around the base of the shower pan, the top of the tile, and at all angled planes in or near the shower. Silicone not recommended.

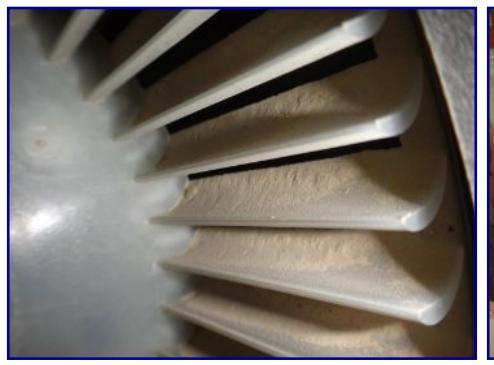
Blower fan dirty. Inside cabinet.

Blower fan dirty. Repair. FYI: Prevent energy loss or unhealthy air quality. Professionally clean the air handler, blower fan, and evaporator coil.
Access restricted. Repair. FYI: Seal the access cover with removable sealant such as HVAC metal tape.

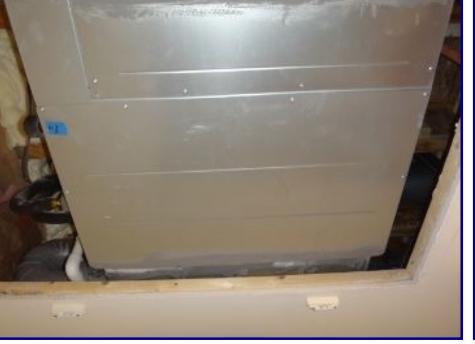
Sealant missing. Cabinet cover. Mastic

installed, service cover not removable.

Condensate drain line trap and cleanout not visible.

• Sealant failed or missing. Repair. FYI: Prevent energy loss, damage from condensation, or dirt in the equipment. Recommend sealing all gaps in the cabinet with duct seal at cabinet penetrations and metal tape at all joints and seams.

• Trap missing. Condensate drain line. Repair. FYI: Prevent energy loss. A trap in the line prevents conditioned air from being pushed out of the drain. Recommend that a trap with a cleanout be installed. Traps need periodic cleaning.

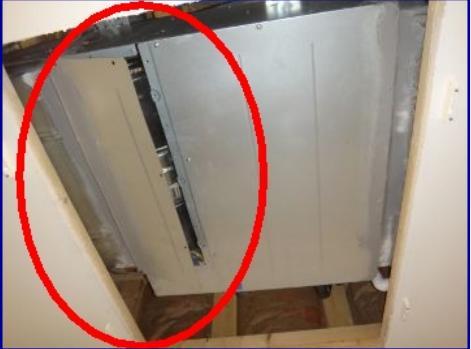
Access restricted. Duct mastic on access cover.

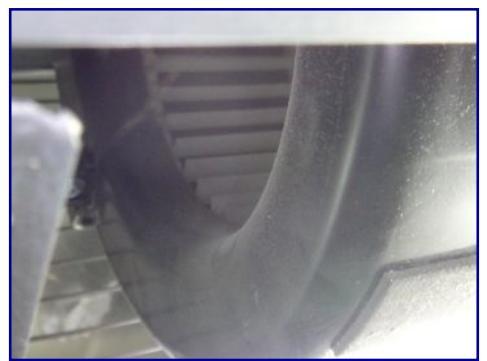
Blower fan dirty. Inside cabinet, Cover Condensate drain line trap and cleanout screw stripped, cover not removed.

• Trap missing. Condensate drain line. Repair. FYI: Prevent energy loss. A trap in the line prevents conditioned air from being pushed out of the drain. Recommend that a trap with a cleanout be installed. Traps need periodic cleaning.

Cover screw stripped. Repair. FYI: Ensure inspection and maintenance. Replace screw.
 Sealant missing. Repair. FYI: Prevent energy loss, damage from condensation, or dirt in the equipment. Recommend sealing all gaps in the cabinet with duct seal at cabinet penetrations and metal tape at all joints and seams.

• Blower fan dirty. Repair. FYI: Prevent energy loss or unhealthy air quality. A dirty fan suggests that the heat exchanger may also be dirty. Professionally clean the air handler,

blower fan, and evaporator coil.

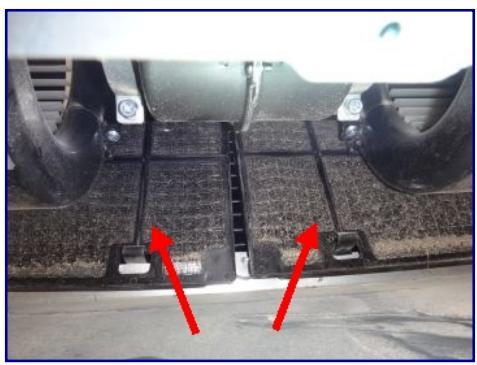
Air filters dirty. Filters redundant. Inside basement air handler cabinet.

Air filter redundant. Basement. Repair. FYI: Prevent flow restriction or lack of maintenance. Recommend that the internal filter be removed. Air filter size mismatched? Further evaluation advised FYI: The larger basement system appears to have a smaller filter and return. Ensure that the systems are sized correctly. Recommend a gualified HVAC contractor.

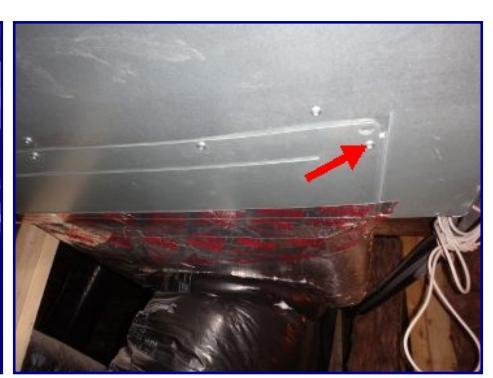
Cover screw stripped. Cover not removed. Sealant missing.

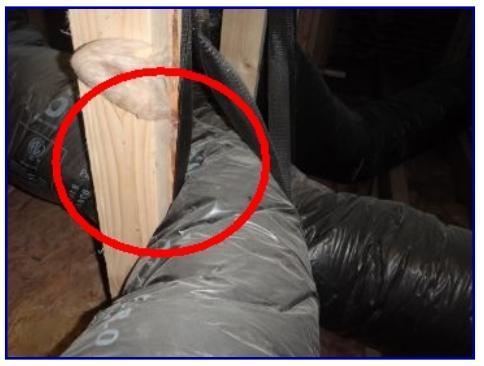
Duct bend excessive. Attic.

• Duct bend excessive. Repair or replace. FYI: Excessive bends create drag and inhibit air flow. Install flexible duct so that the radius of the bend at the duct centerline is no less than the diameter of the duct.

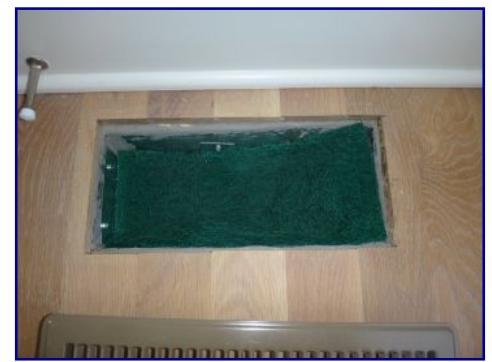
Registers blocked. Filters.

Observations: • Registers blocked. Repair. FYI: Prevent inefficient operation. Clean and clear all registers.

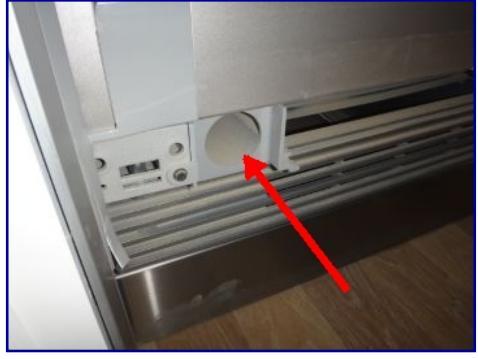
Water filter missing.

• Water filter missing. Repair. FYI: Install filter or filter cap.

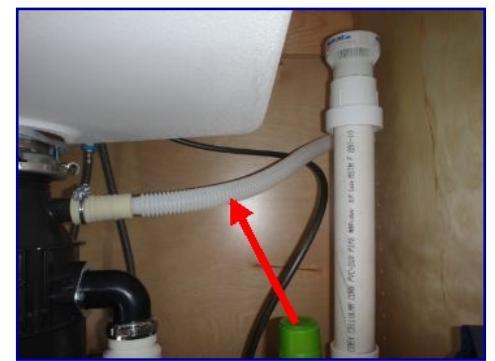
Dishwasher drain high loop missing. Under kitchen sink.

• Dishwasher drain line high loop missing. Repair. FYI: Prevent sink drain backflow into dishwasher. Secure the dishwasher drain line no lower than directly to the underside of the countertop.

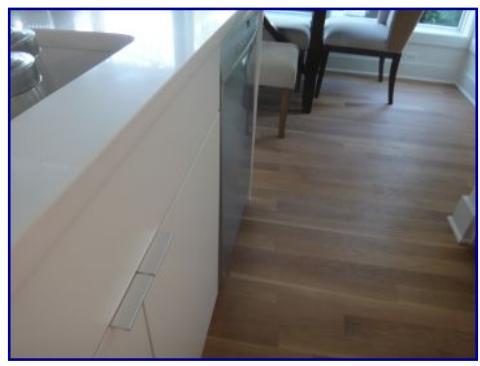
Dishwasher out-of-plumb. Leans back.

• Dishwasher out-of-plumb. Repair. FYI: Typically the feet can be turned to adjust the height of each corner. Ensure that the dishwasher is level left-to-right and front-to-back.
